**Workdry Ltd**  
**New Headquarters Office Building**  
**Bournemouth Road, Chandlers Ford**

**Drainage Design Statement**

**Date: November 2025**  
**Project No. 304846**  
**Report Reference: 304846-SWH-ZZ-ZZ-T-C-0002**  
**Revision: 01**

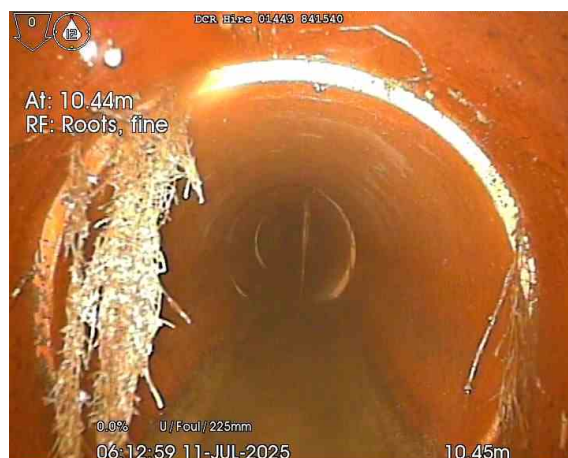
FW2301 US\_10-45m\_061259.jpg, 00:01:18, 10.45 m  
Roots, fine

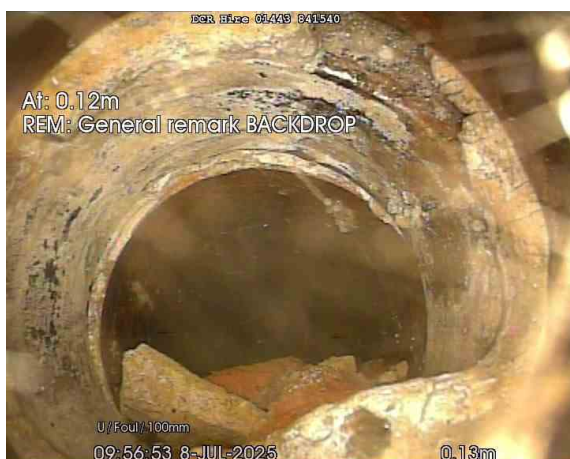
MH03 BR3\_0-13m\_095653.jpg, 00:00:31, 0.13 m  
General remark, BACKDROP
